FCM32F0xx/FCM32H0xx Application Notes

(For D Version IC)

This document applies to FCM32x030, FCM32x031 and FCM32x042.

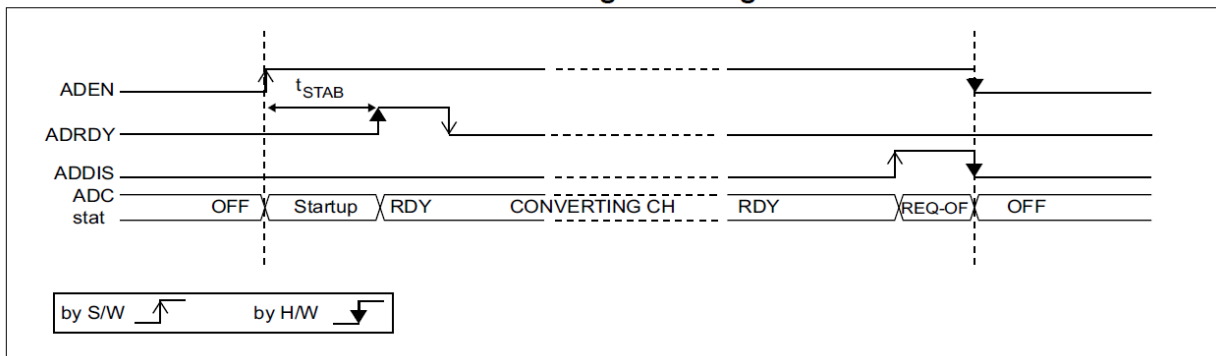
Enabling/disabling the ADC

3.2.4 ADC Trigger be lost before ADC RDY

After the ADC allowed, it needs to wait the time of t_{STAB} before allowing the conversion, during this period, the ADC trigger is invalid (including software trigger).

Therefore, after the ADC allowed, and the ADC software trigger is executed at once, ADC will not initiate the conversion. As shown below, some users' program do not follow this rule.

Solution:

Wait for the ADC to be READY before starting the conversion, using the code in the red box instead of the previous line.
